**DESIGN, FABRICATION, AND STRUCTURAL EVALUATION OF  
AN ADVANCED COMPOSITE HYDROFOIL CONTROL FLAP**

by  
**William P. Couch**

**STRUCTURES DEPARTMENT  
TEST AND EVALUATION REPORT**

November 1982

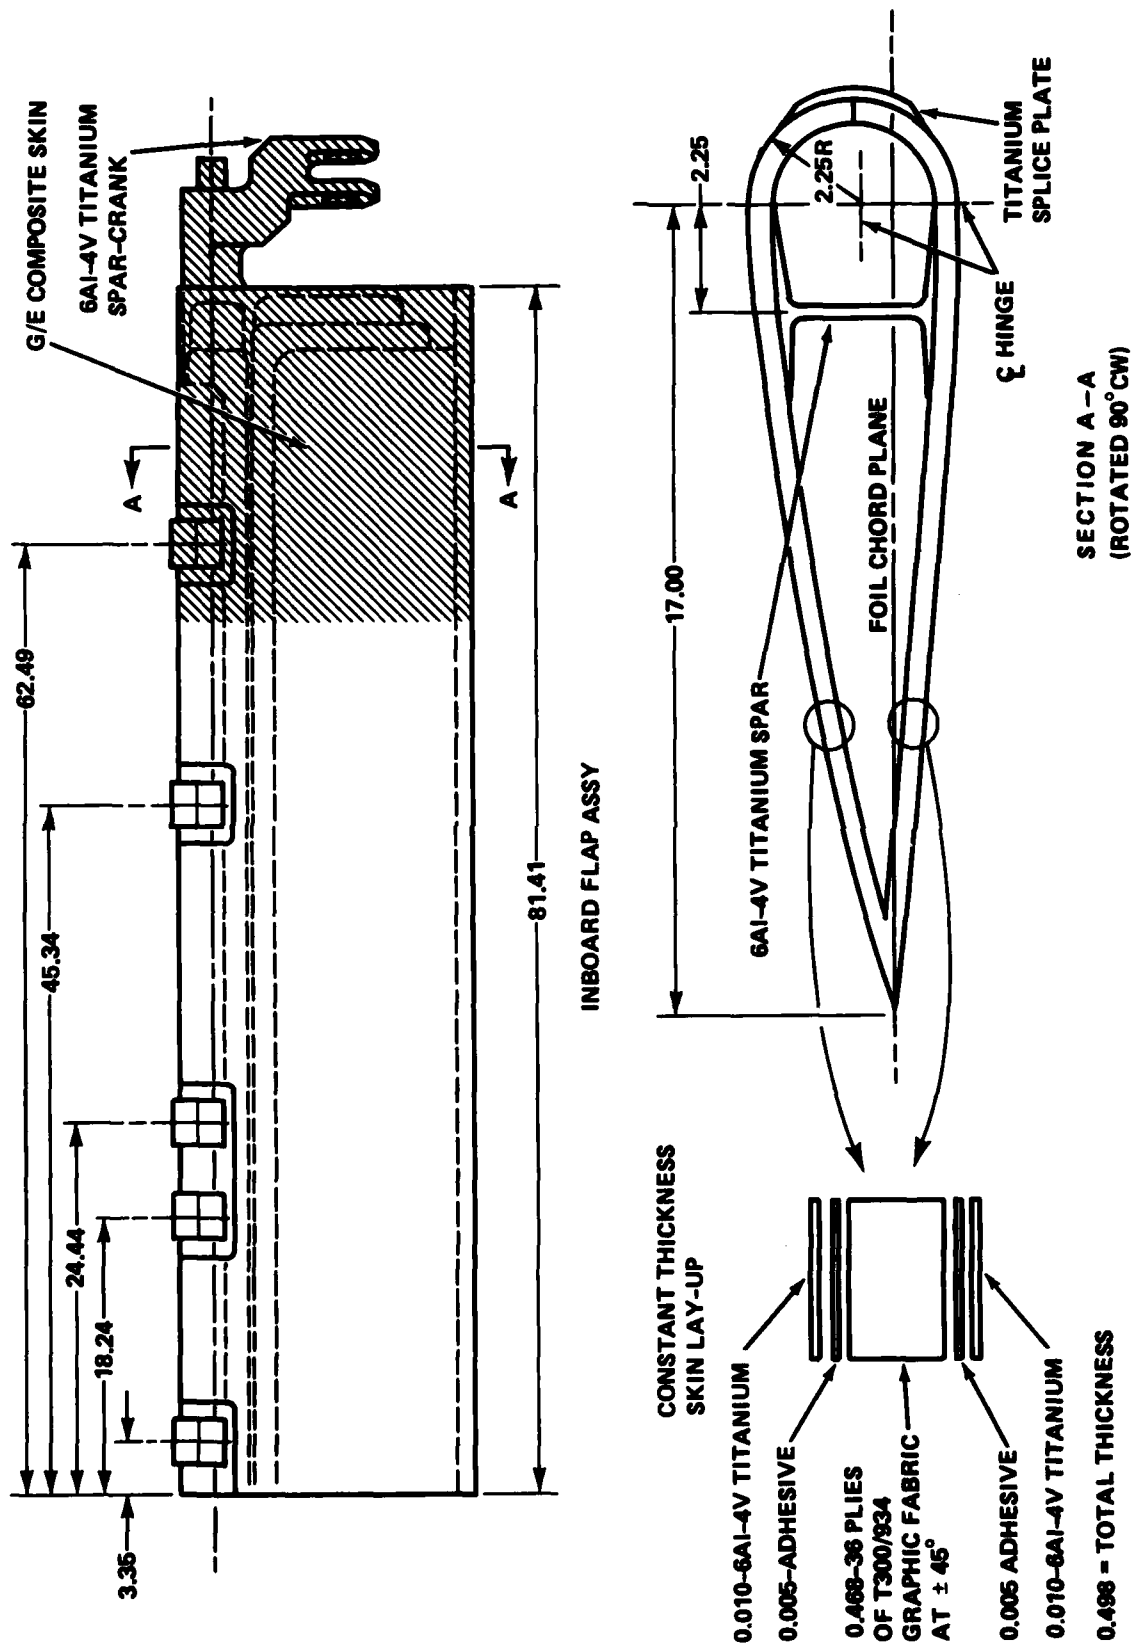
Figure 3 - Details of Preliminary Design

In order to verify the design and fabrication processes and to evaluate joints, a full-scale portion of the flap was built and tested. This feasibility component incorporates the first 20 inches of the flap, end joint, and crank fitting; see the shaded area in Figure 3. The feasibility component sustained a static proof test to the maximum operating load, or 40 percent of design ultimate. The component failed after approximately 12,000 cycles (safe life =  $16 \times 10^6$  cycles) due to a debond along the leading edge, which changed the load path and resulted in a catastrophic failure of the titanium end fitting. In order to simulate actual service experience in the

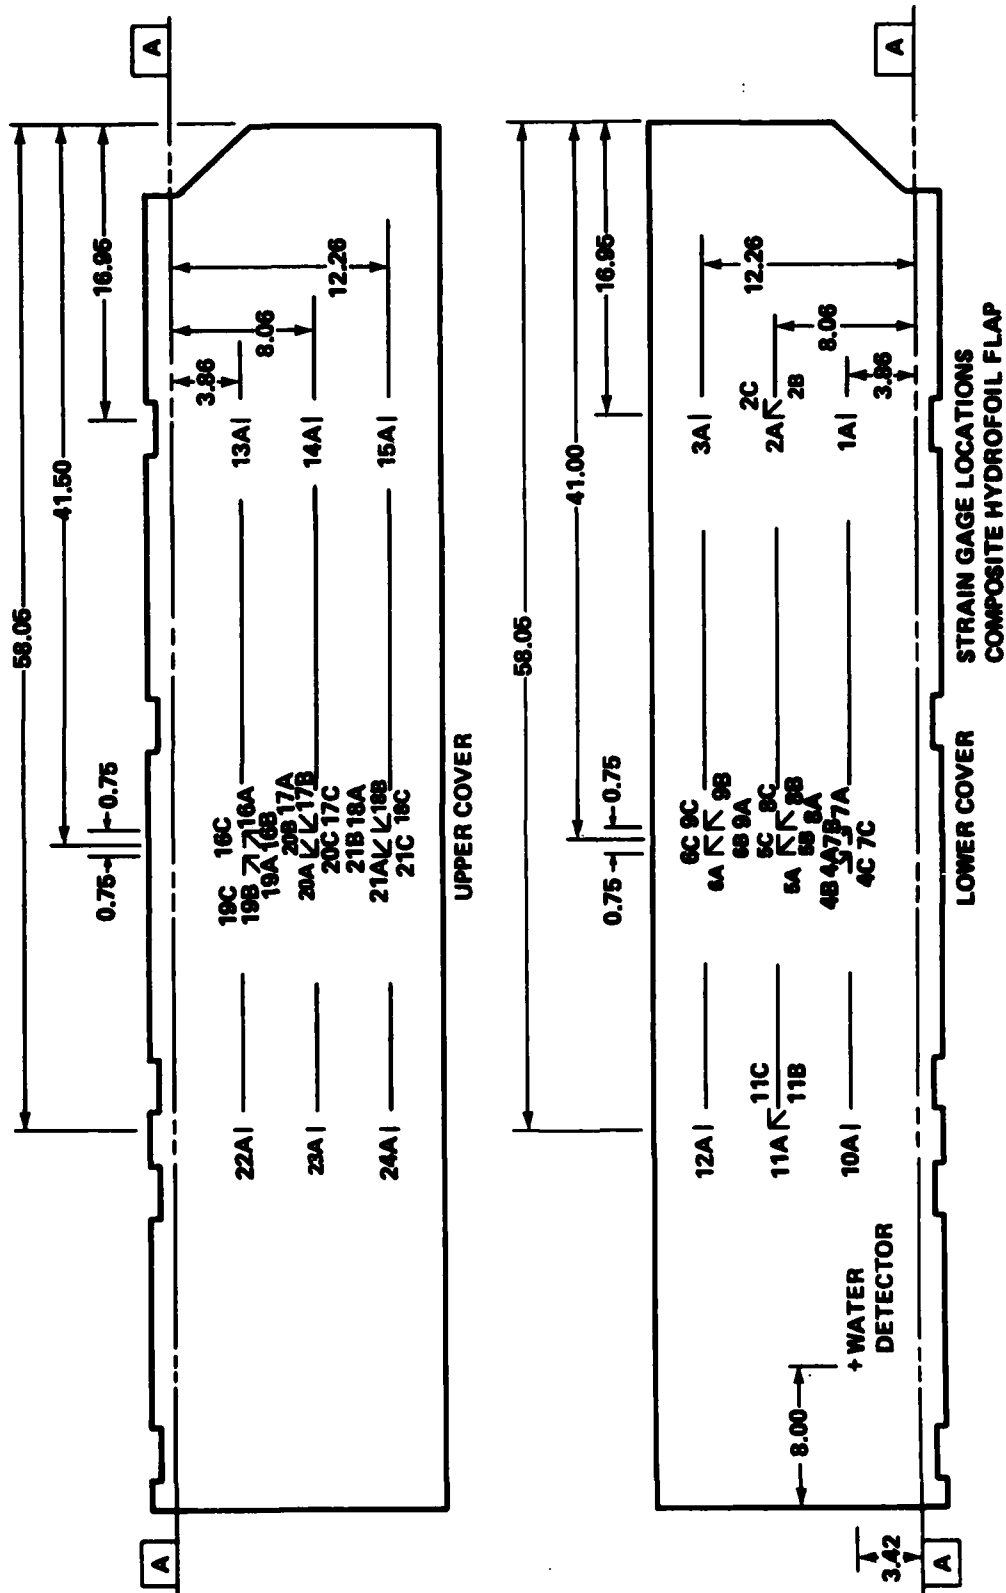
Figure 6 - Cover Strain Gage Locations

All flap gages were up and functioning normally from the time the flap was installed on PCH-1 until the ship was placed in the water. After the ship was lowered into the water and the struts fully extended, a check of the strain gages revealed that 75 percent of the gages were inoperable. The water detection gage did not show the presence of water in the flap, so it was assumed that the gage leads had been severed when the struts were extended to the fully submerged condition. The actual cause of gage malfunction has never been determined. Calm water trials were initially tried in October 1979, but were terminated before completion due to unrelated mechanical difficulty with PCH-1. Calm water trials were rescheduled and conducted in July 1980; only those gages circled in Figure 6 were active to monitor flap strains for the purpose of determining pressure loads.

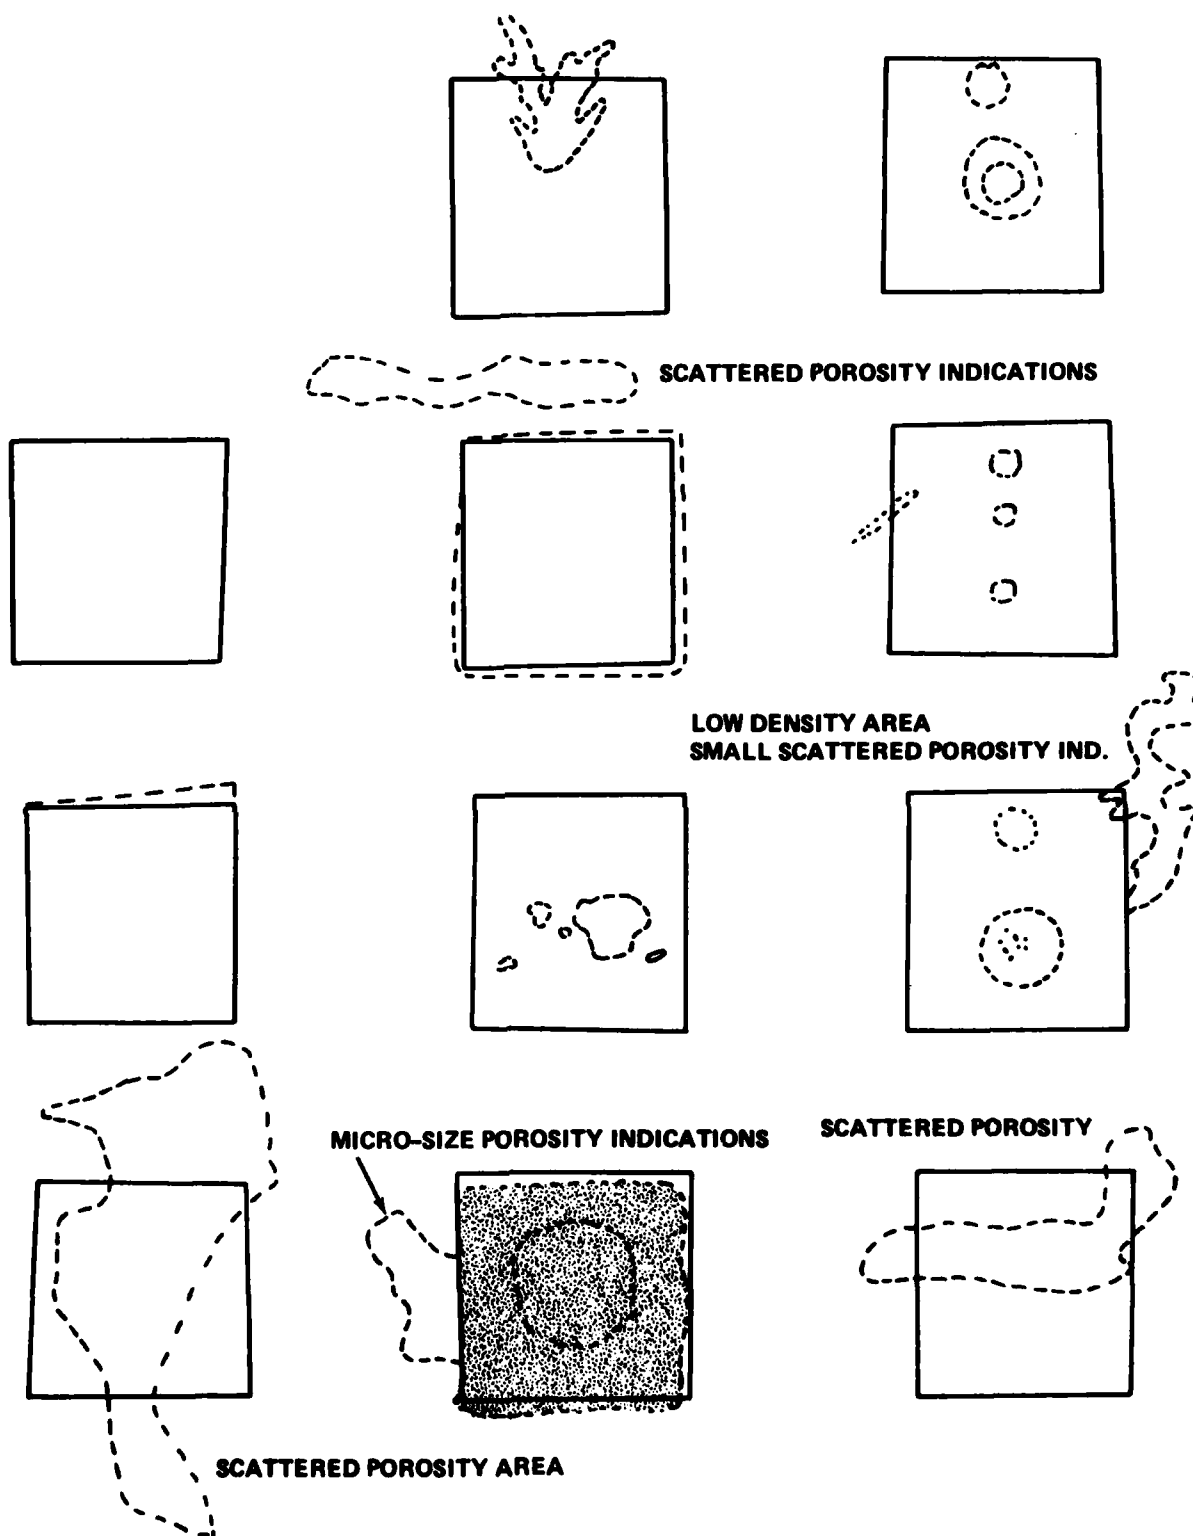
Figure A.4 - Results of X-Ray with Image Enhancement Analysis

the laminate (water tank or water jet) and because the small transducer required to concentrate the ultrasonic energy leads to a large amount of time for inspection (unless multiple transducers are used). If flaws in the post cured laminate are detected with this method, the radiographic analysis with an image enhancement system and a calibrated density profiler can be used to give an accurate three-dimensional characterization of the flaws. The pulse-echo ultrasonics should be used when both sides of the laminate can be inspected and when the more sophisticated through-transmission ultrasonics is not available, or when the component is too large to make through-transmission feasible.
